**Report No. CTS-GSSI-21-130**

# **Report on Concrete Scanning using Ground Penetration Radar by Structural Scanner for As built Structural Details on Ground Floor Slab for Building a Mezzanine Floor on the Ground Floor Slab**

**Project: ATOLYE Office, Emirates Tower - Dubai - UAE**

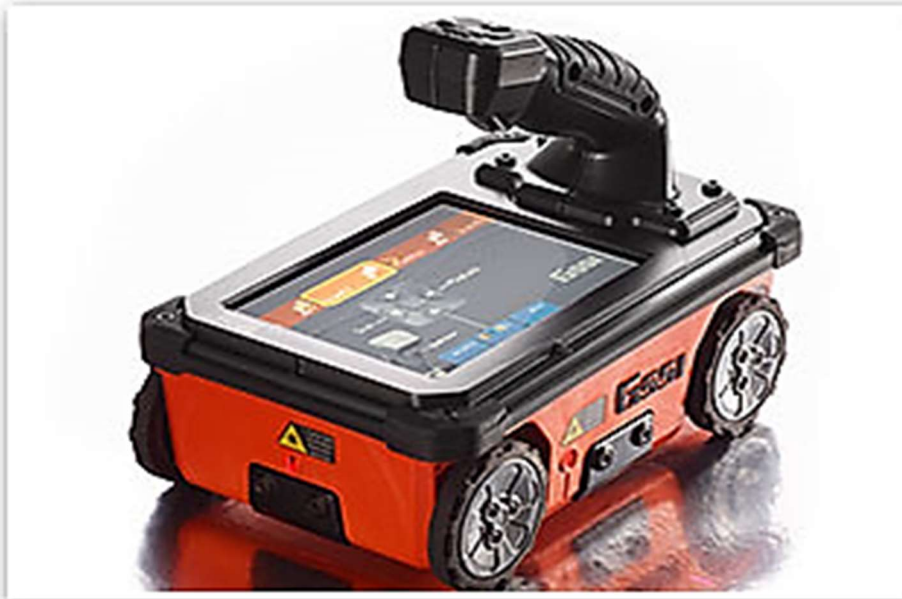
Scanning Ground Penetration Radar (SC-GPR) was performed on 20<sup>th</sup> & 21<sup>st</sup> January-2021, at the selected areas on the ground floor level slab by the client utilizing the Digital Control Unit (GSSI structure Scanner, made in USA), Fig. (2.1)

Figure 2.1 The system of GSSI-Structural Scanner

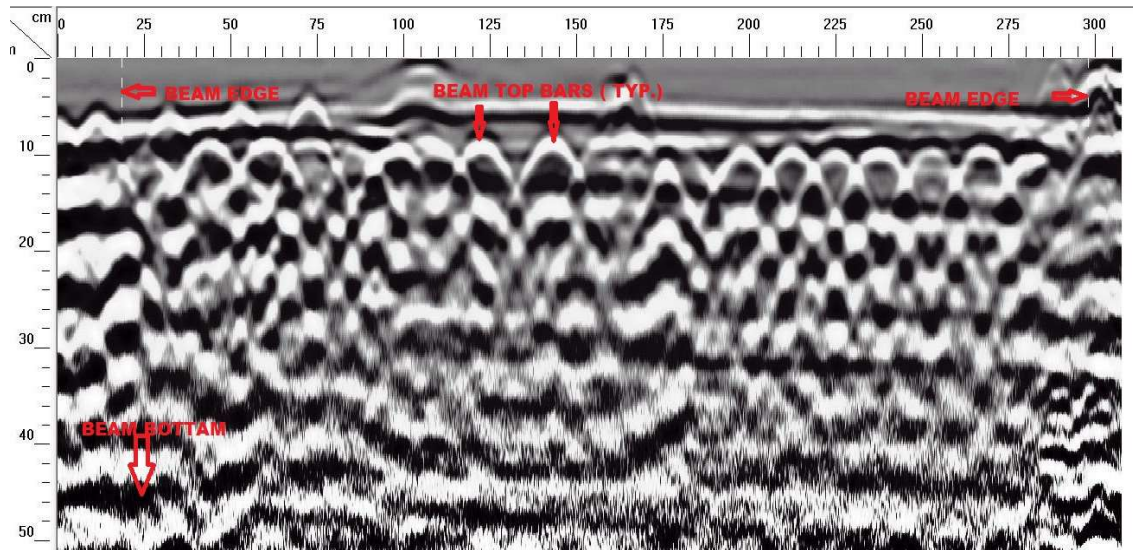
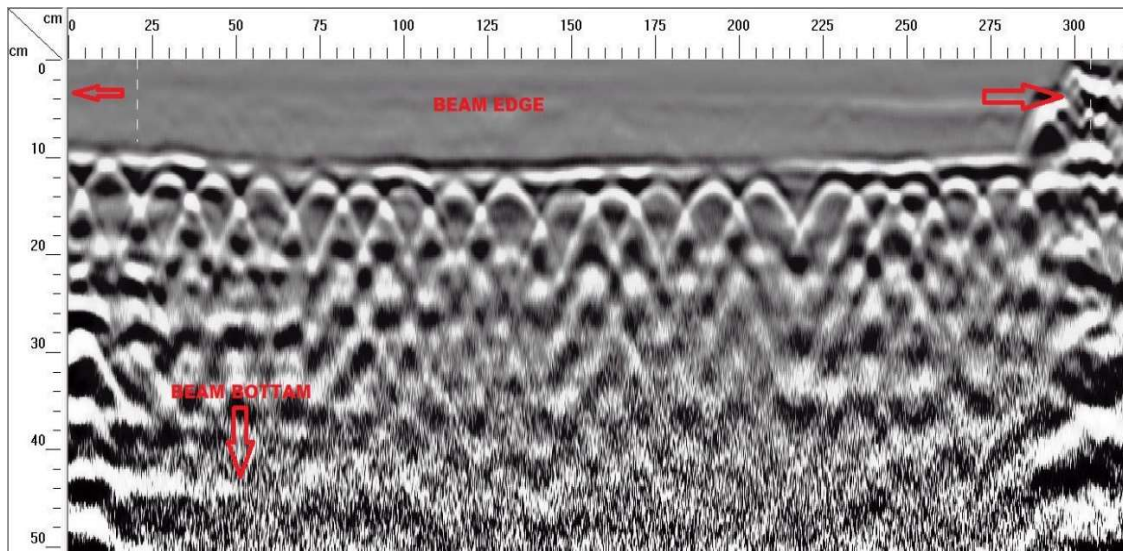
**5.2: layout of ground floor beam top images**

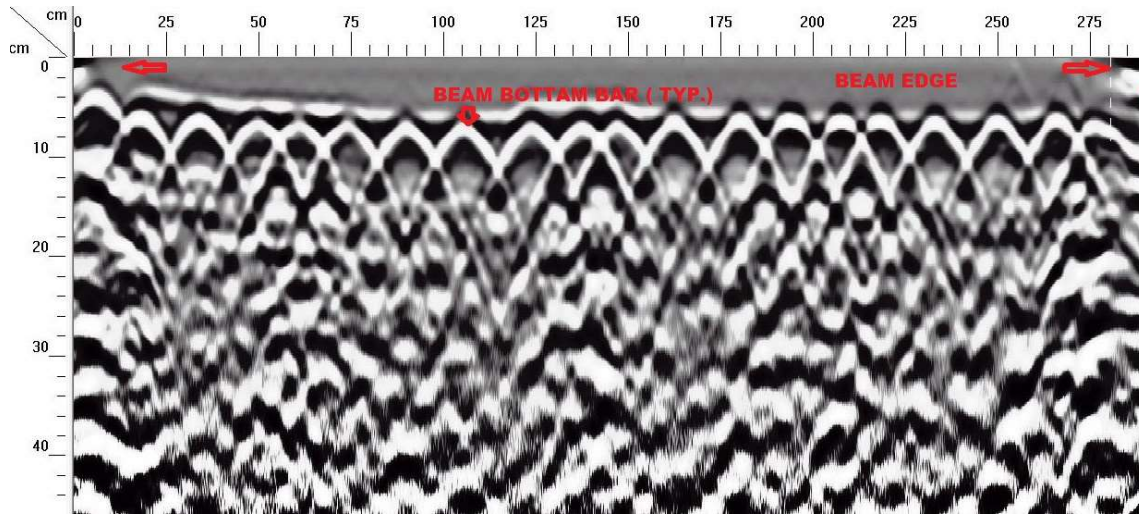
**Figure 5.3: GPR Image of beam bottom**

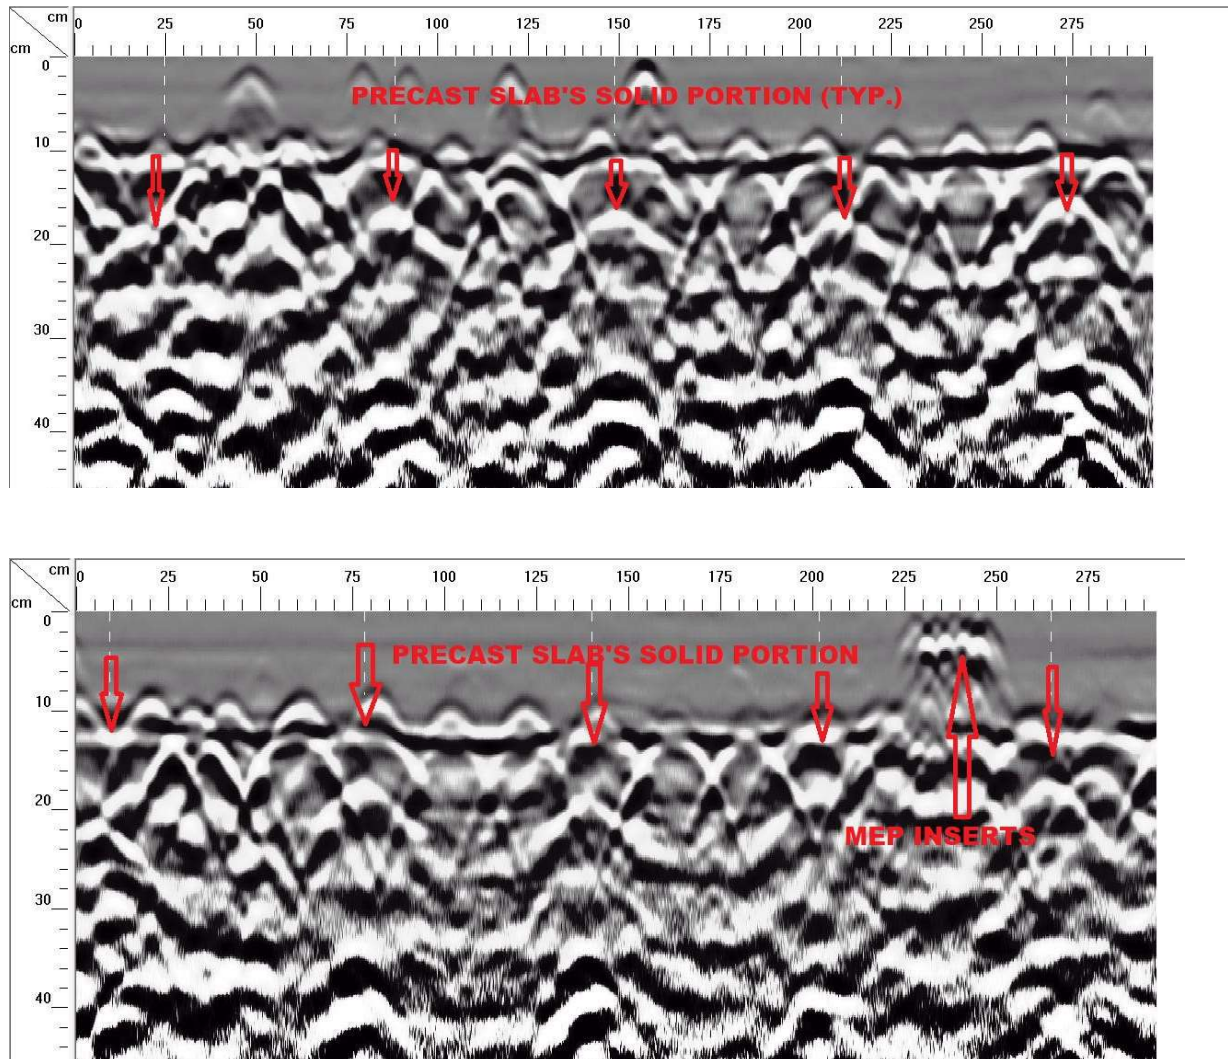
**Figure 5.4: GPR Images From Top of the Precast Slab**

The C-7 & C-4 columns location are on 300 mm thick precast slab including 75 mm thick structural screed with A393 welded mesh. The precast size is 2.6m width x 300 mm thick x 7.4 m long and is placed on the nib of the 2.8 m width beam ( Beam -A & Beam- B). The scanning from the top of the slab shows that, at every 600 mm a 60 mm thick solid portion and remaining area is hollow. Due to the restriction, the below floor scanning concert was not done.

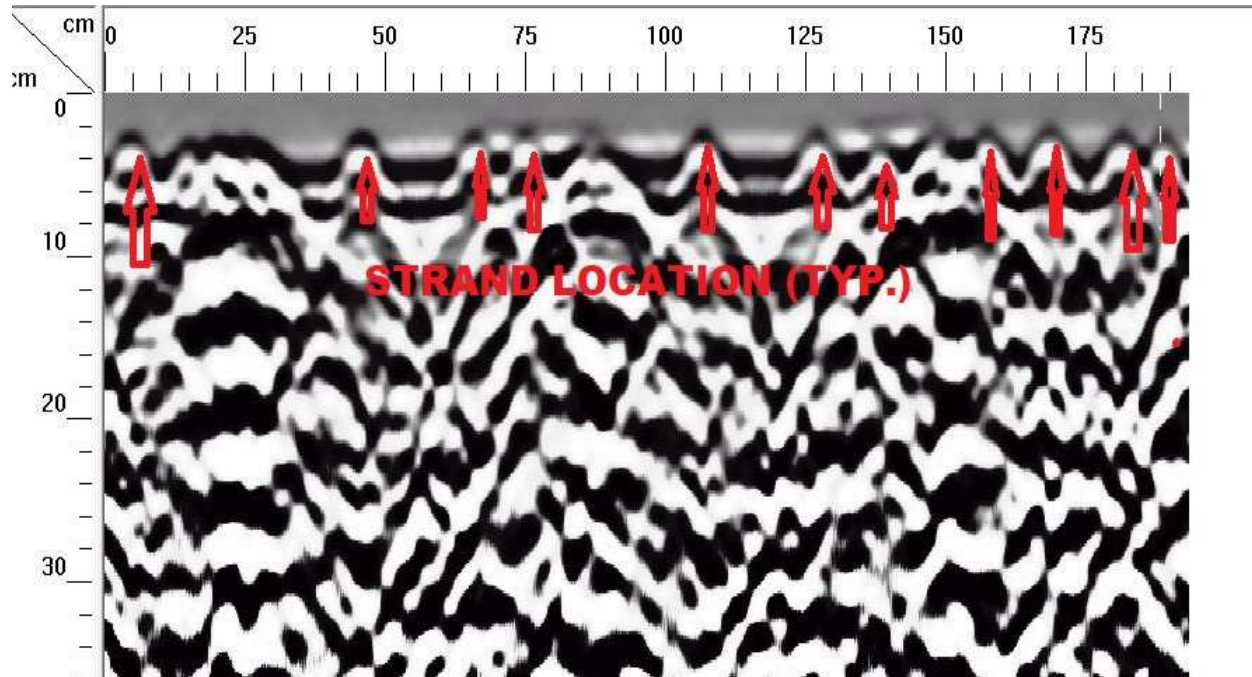
Figure 5.5: Precast slab's Strand location at slab bottom level

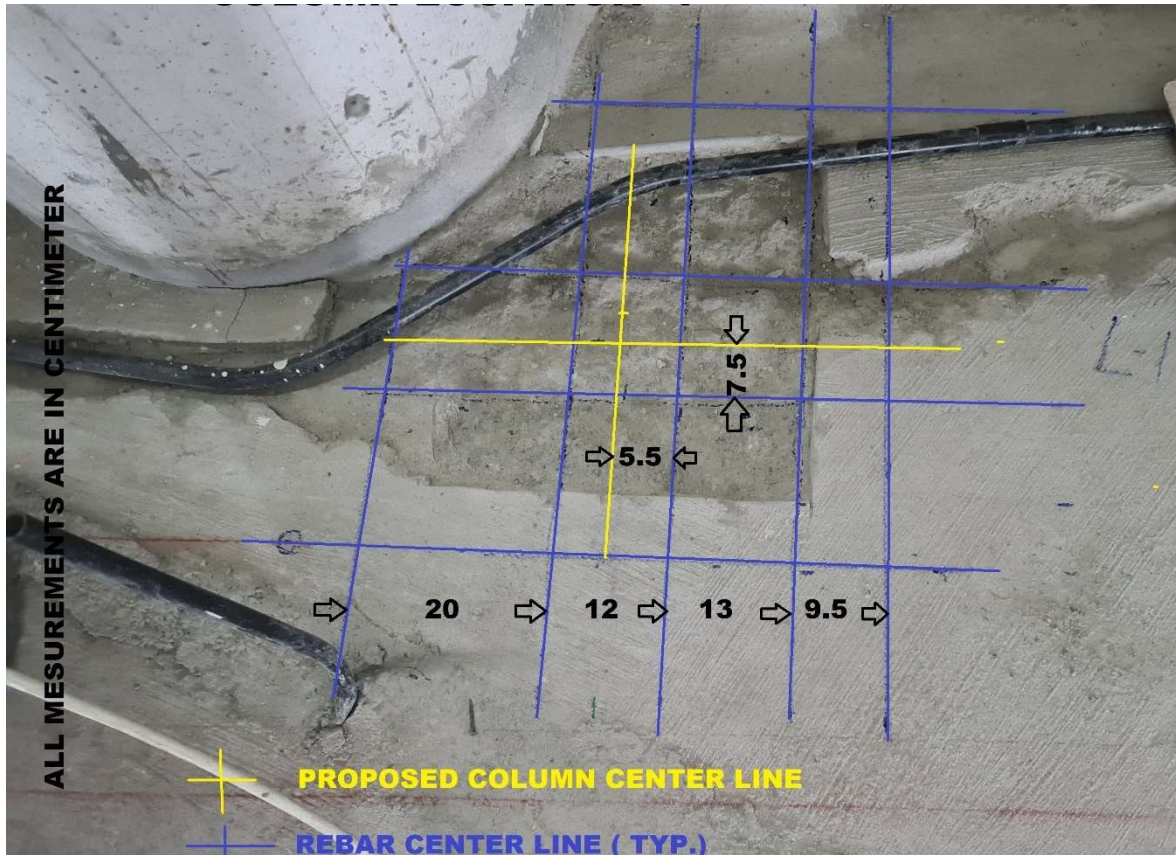
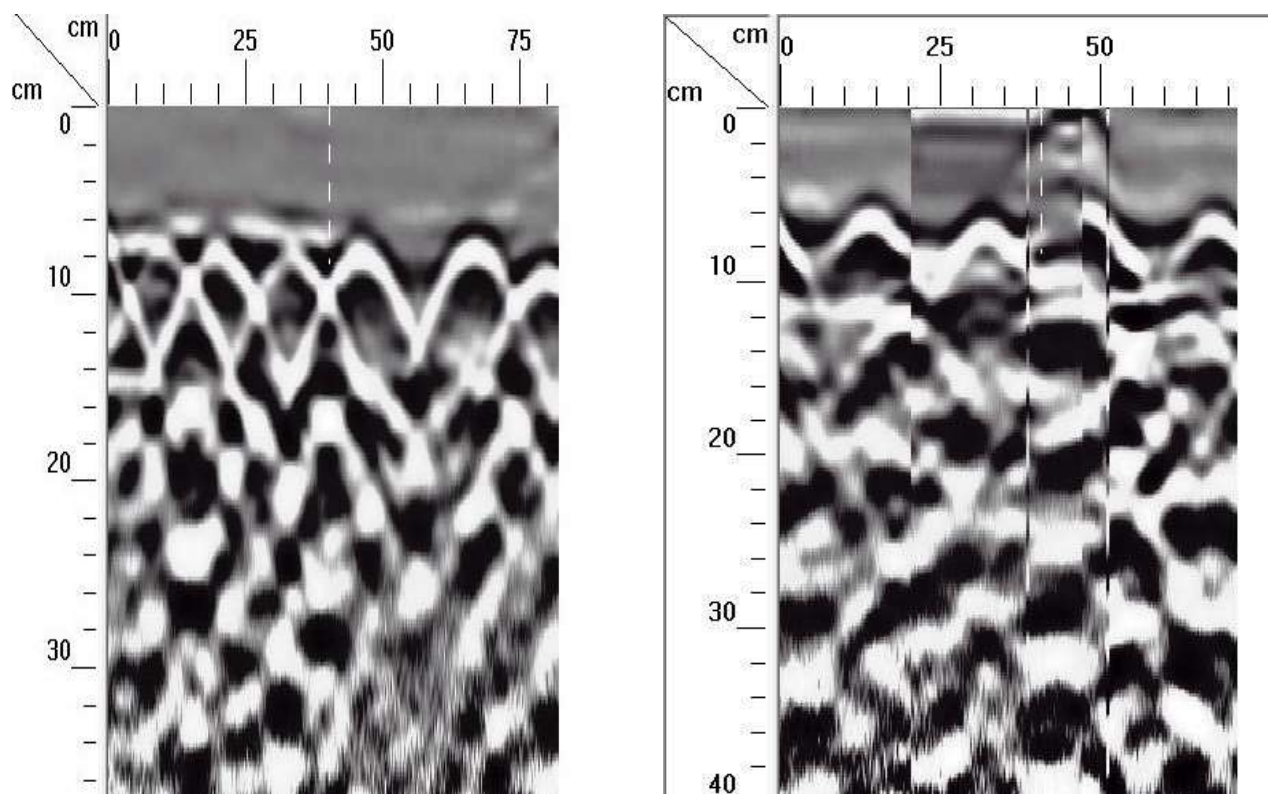
Figure 5.6: Rebar & Proposed column location -1 Layout

**Figure 5.7: GPR Images of Column location -1**

Based on the results of SC-GPR survey, the proposed column location -1 on the 2.8m width x 450 mm beam ( Beam-A) is very near to the 600 mm dia. circular column. The column location is 420 mm from the center of the beam-A towards right side & 335 mm from the column center line ( Column RC-1 & RC-2 ) downwards ( See Figure 5.1). The rebar center line and proposed column center line is physically marked on the floor ( See Figure 5.6). From the center of the rebar, 25 mm plus half of the dia. of the hole will be safe drilling location in all directions. However this subject to structural Engineers approval for final drilling location.

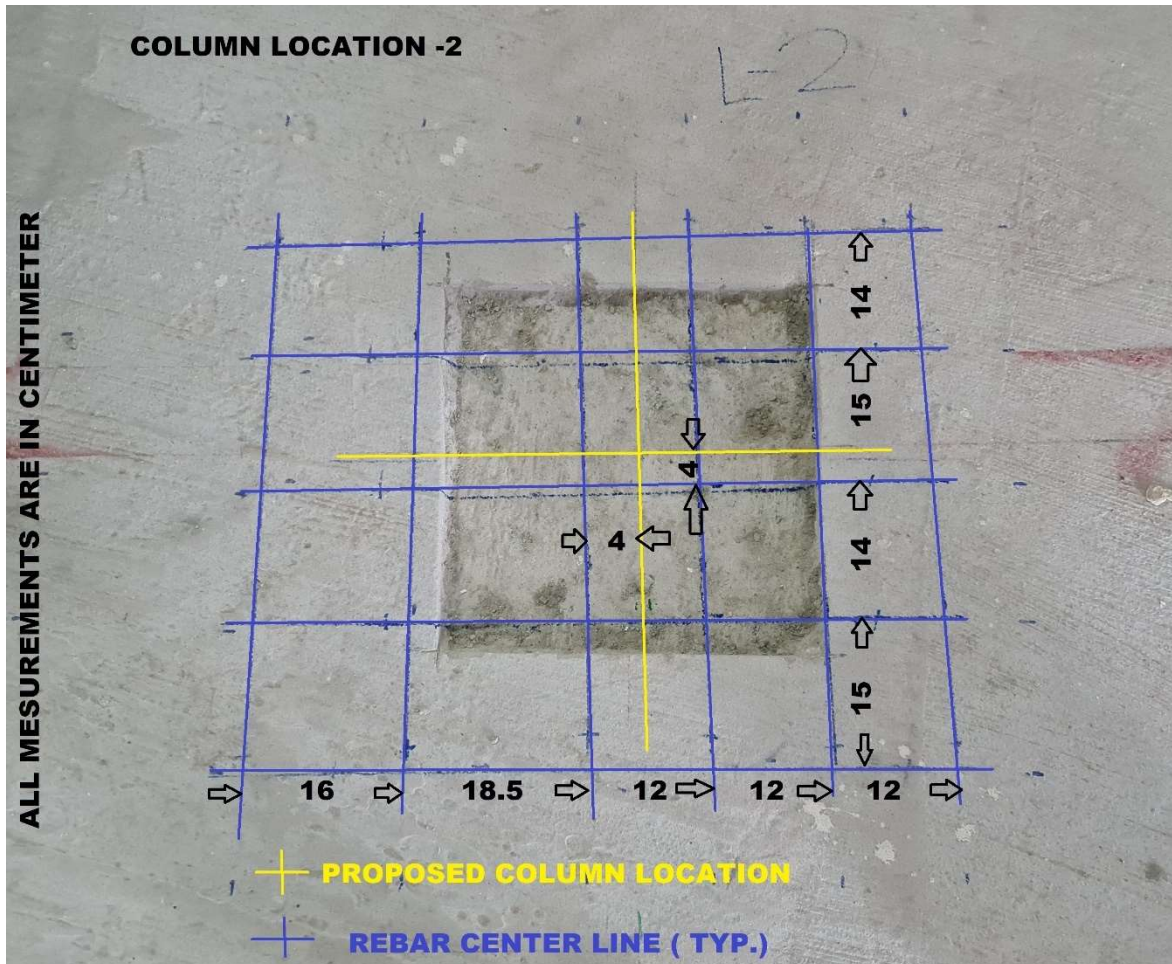
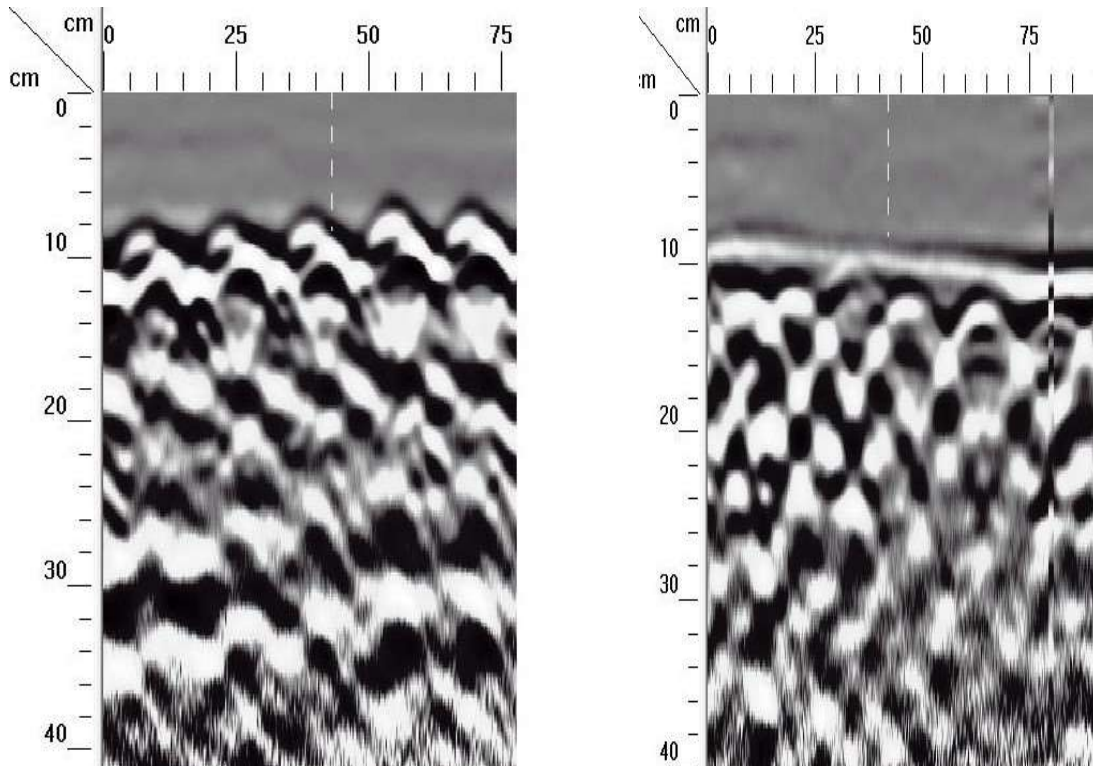
Figure 5.8: Rebar & Proposed column location -2 Layout

**Figure 5.9 : GPR Images of Column location -2**

Based on the results of SC-GPR survey, the proposed column location -2 on the 2.8m width x 450 mm beam ( Beam-A). The column location is 420 mm from the center of the beam towards right side & 1945 mm from the column center line downwards (Column RC-1 & RC-2 See Figure 5.1). The rebar center line and proposed column center line is physically marked on the floor ( See Figure 5.8). From the center of the rebar, 25 mm plus half of the dia. of the hole will be safe drilling location in all directions. However this subject to structural Engineers approval for final drilling location.

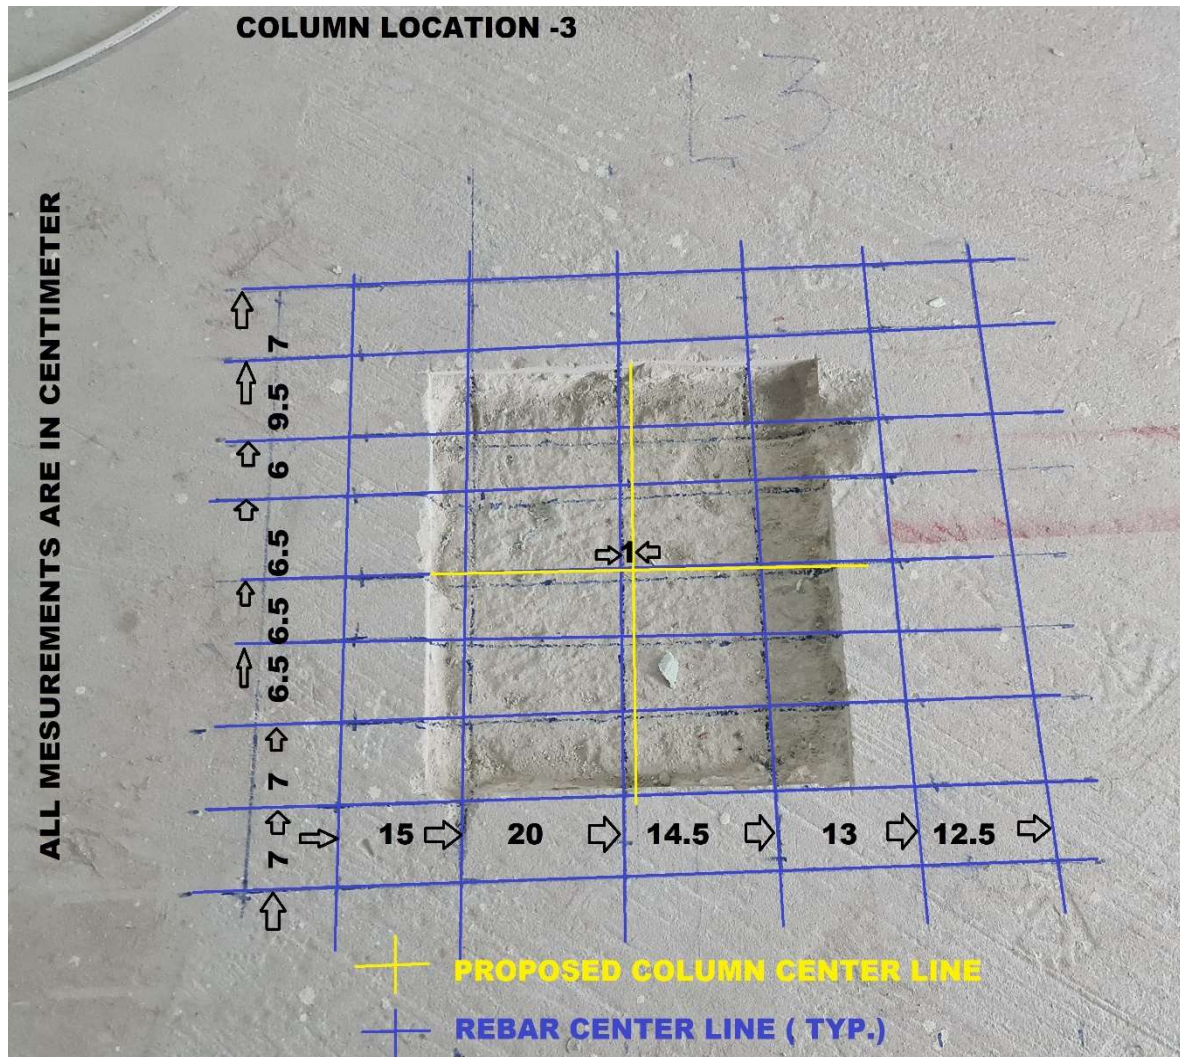
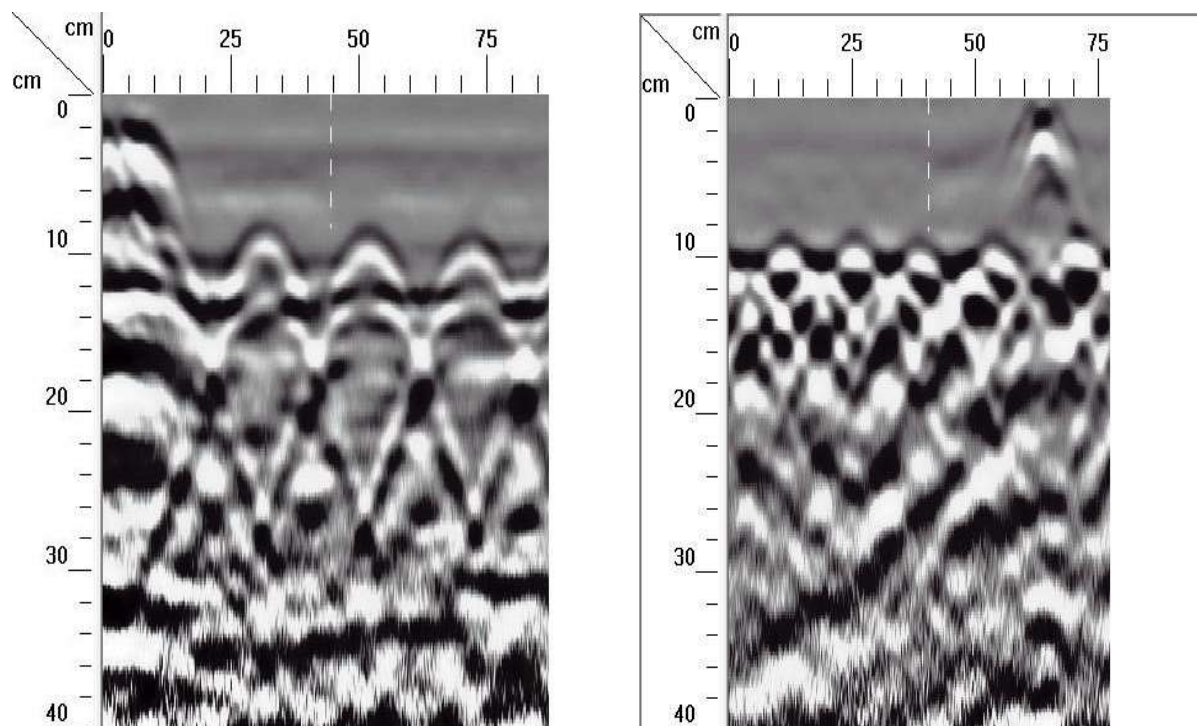
Figure 5.10: Rebar & Proposed column location -3 Layout

**Figure 5.11 : GPR Images of Column location -3**

Based on the results of SC-GPR survey, the proposed column location -3 on the 2.8m width x 450 mm beam ( Beam- A). The column location is 420 mm from the center of the beam towards right side & 3995 mm from the column center line downwards ( See Figure 5.1). The rebar center line and proposed column center line is physically marked on the floor ( See Figure 5.10). From the center of the rebar, 25 mm plus half of the dia. of the hole will be safe drilling location in all directions. However this subject to structural Engineers approval for final drilling location.

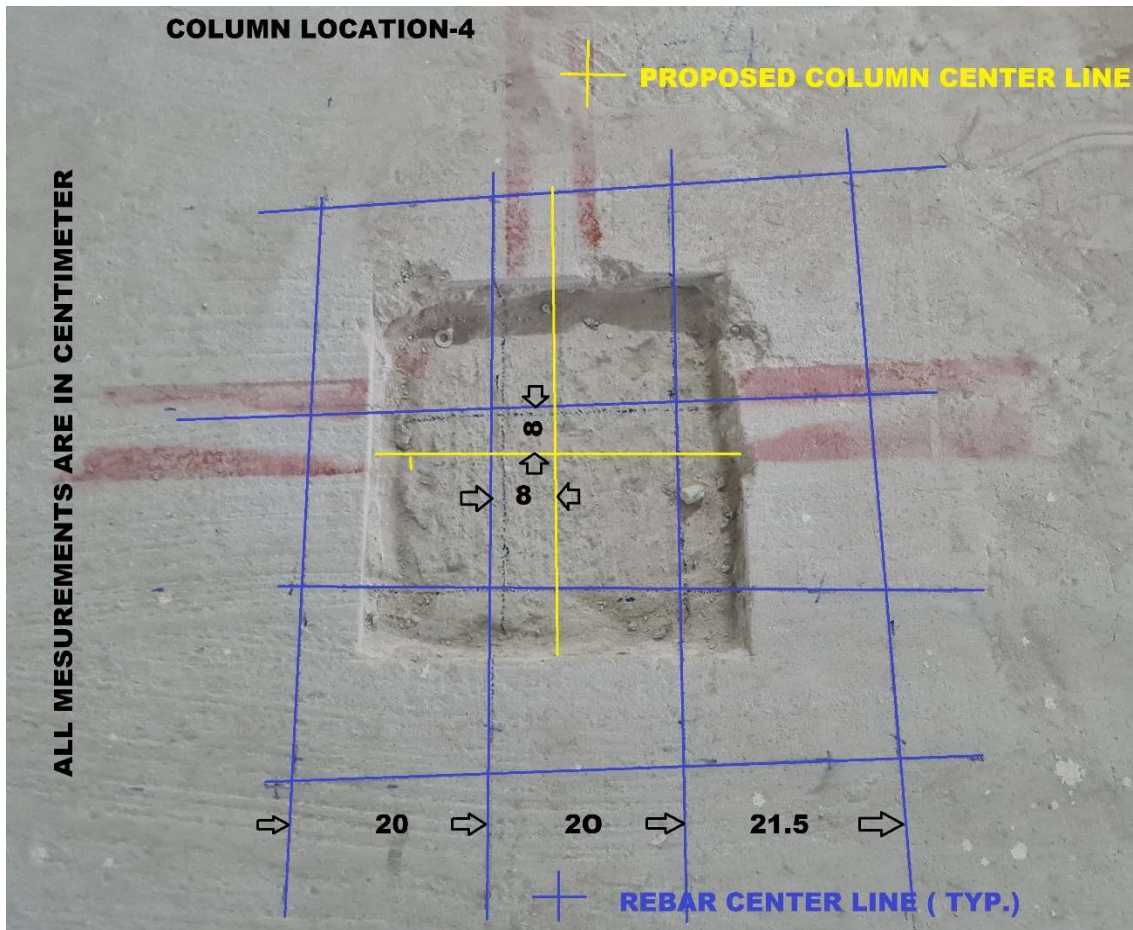
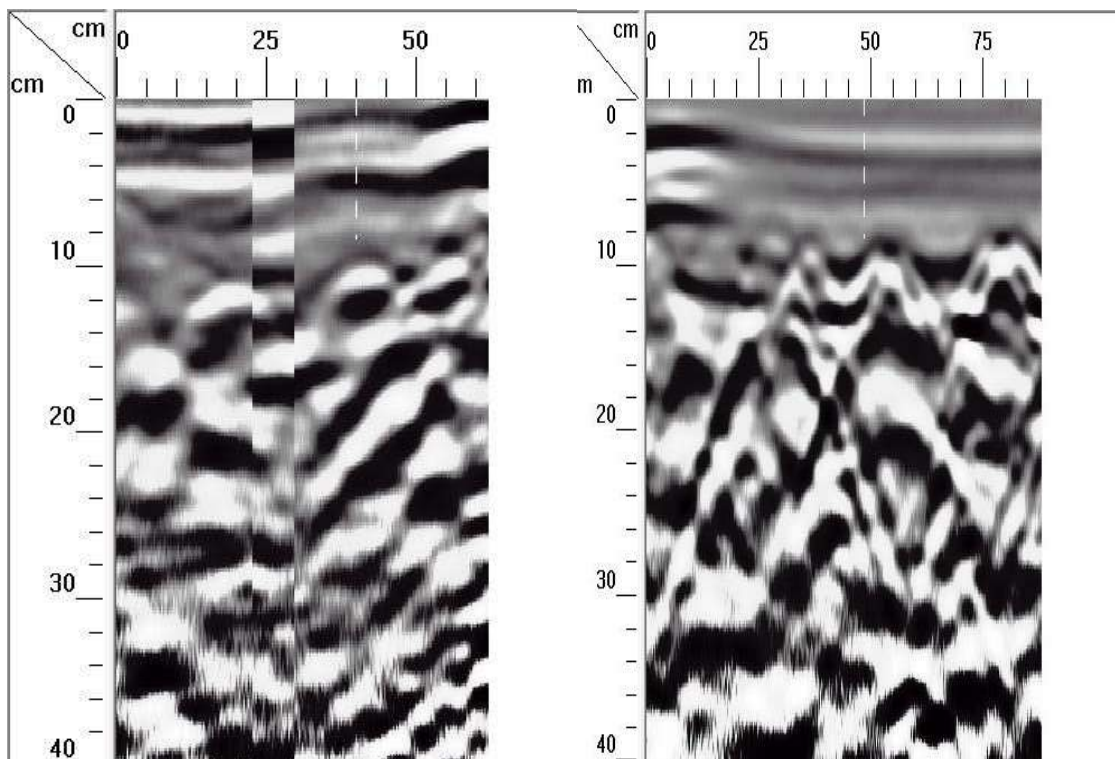
Figure 5.12: Rebar & Proposed column location -4 Layout

**Figure 5.13: GPR Images of Column location -4**

Based on the results of SC-GPR survey, the proposed column location -4 on the 2.6m width x 300 mm thick precast slab. The column location is 2490 mm from the center of the beam (Beam-A) towards left side & 3995 mm from the RC-1 & RC-2 center line downwards ( See Figure 5.1). The rebar center line and proposed column center line is physically marked on the floor ( See Figure 5.12). From the center of the rebar, 25 mm plus half of the dia. of the hole will be safe drilling location in all directions. However this subject to structural Engineers approval for final drilling location.

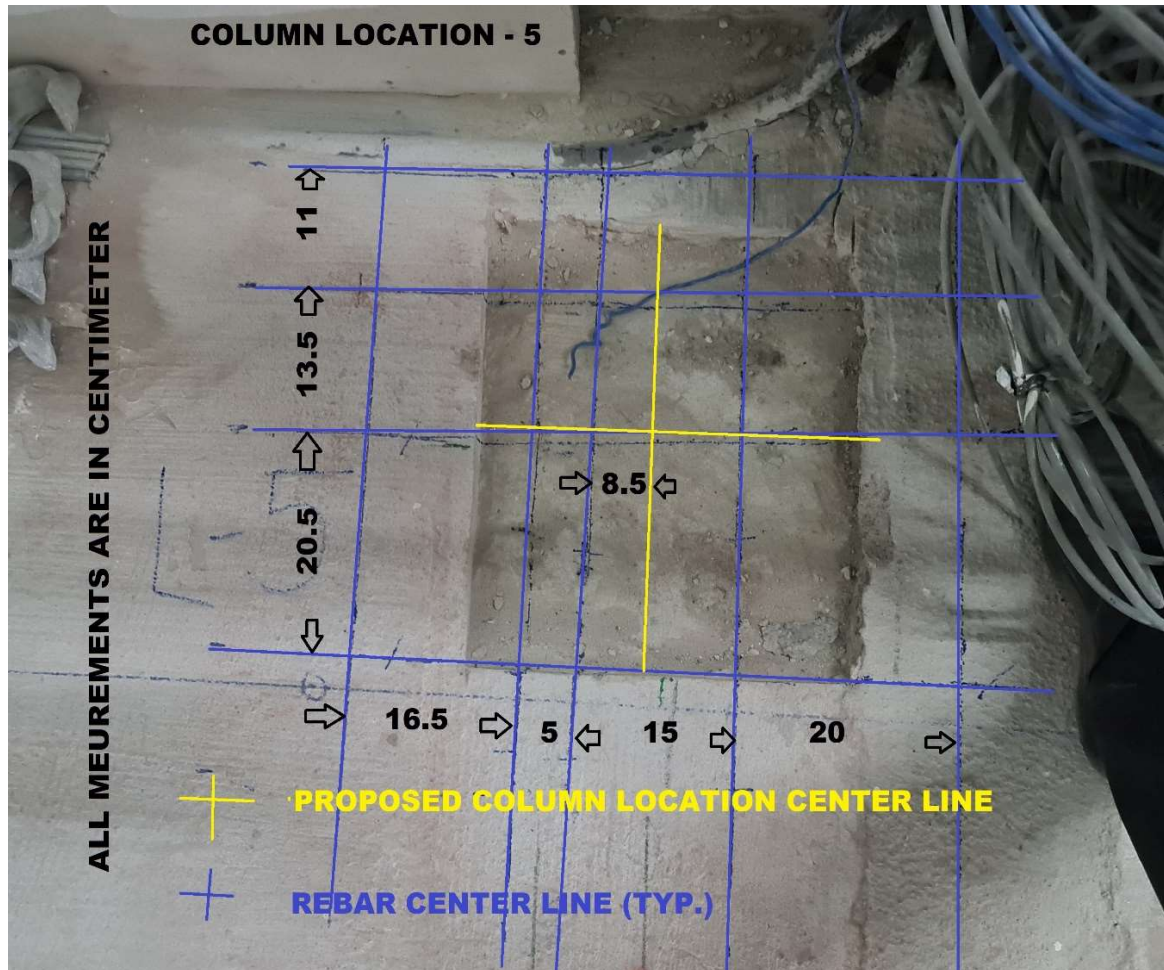
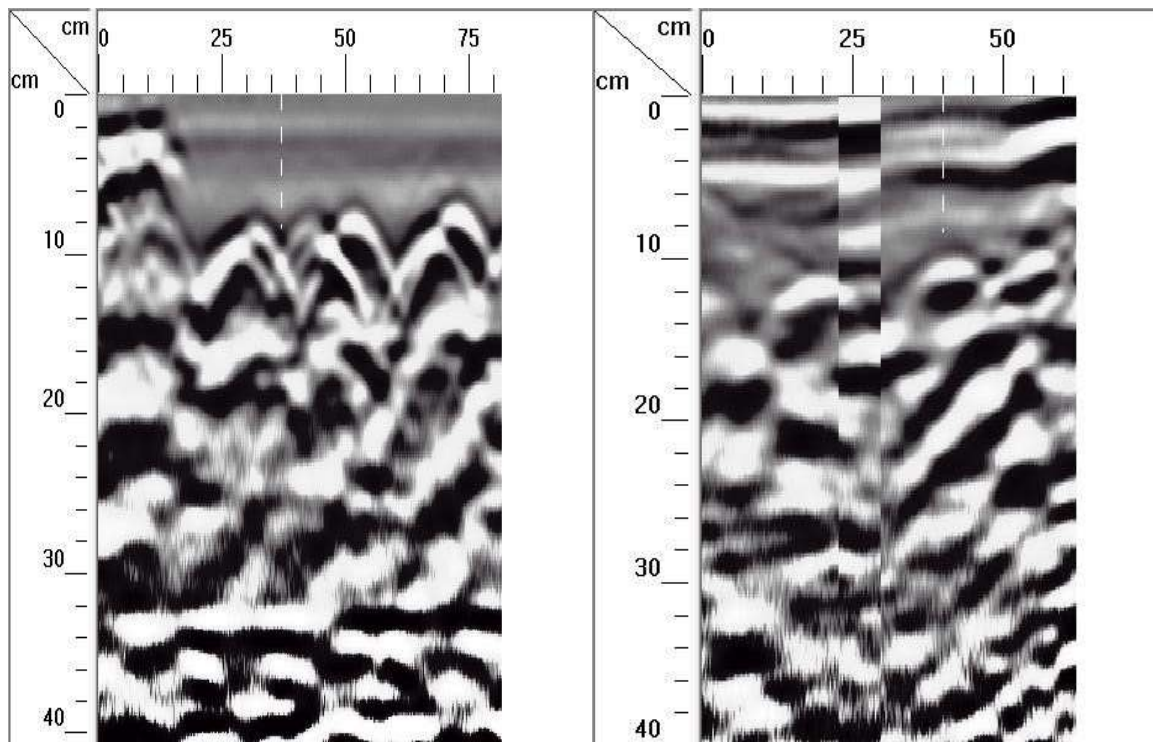
**Figure 5.14: Rebar & Proposed column location -5 Layout**

**Figure 5.15: GPR Images of Column location -5**

Based on the results of SC-GPR survey, the proposed column location -5 on the 300 mm thick solid slab ( Parallel to column RC-1 & RC-2. The column location is 2490 mm from the center of the beam (Beam-A) towards left side & 335 mm from the RC-1 & RC-2 center line downwards ( See Figure 5.1). The rebar center line and proposed column center line is physically marked on the floor ( See Figure 5.14). From the center of the rebar, 25 mm plus half of the dia. of the hole will be safe drilling location in all directions. However this subject to structural Engineers approval for final drilling location.

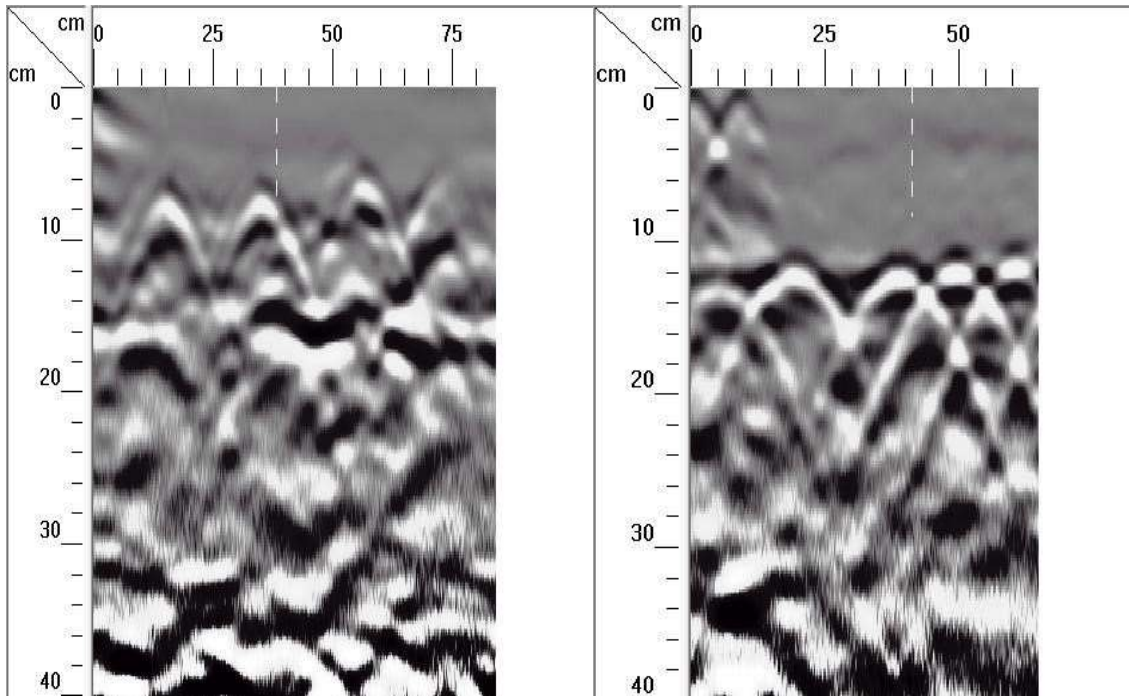
Figure 5.16: Rebar & Proposed column location -6 Layout

**Figure 5.17: GPR Images of Column location -6**

Based on the results of SC-GPR survey, the proposed column location -6 on the 300 mm thick solid slab ( Parallel to column RC-1 & RC-2. The column location is 3950 mm from the center of the beam (Beam-B) towards right side & 335 mm from the RC-1 & RC-2 center line downwards ( See Figure 5.1). The rebar center line and proposed column center line is physically marked on the floor ( See Figure 5.16). From the center of the rebar, 25 mm plus half of the dia. of the hole will be safe drilling location in all directions. However this subject to structural Engineers approval for final drilling location.

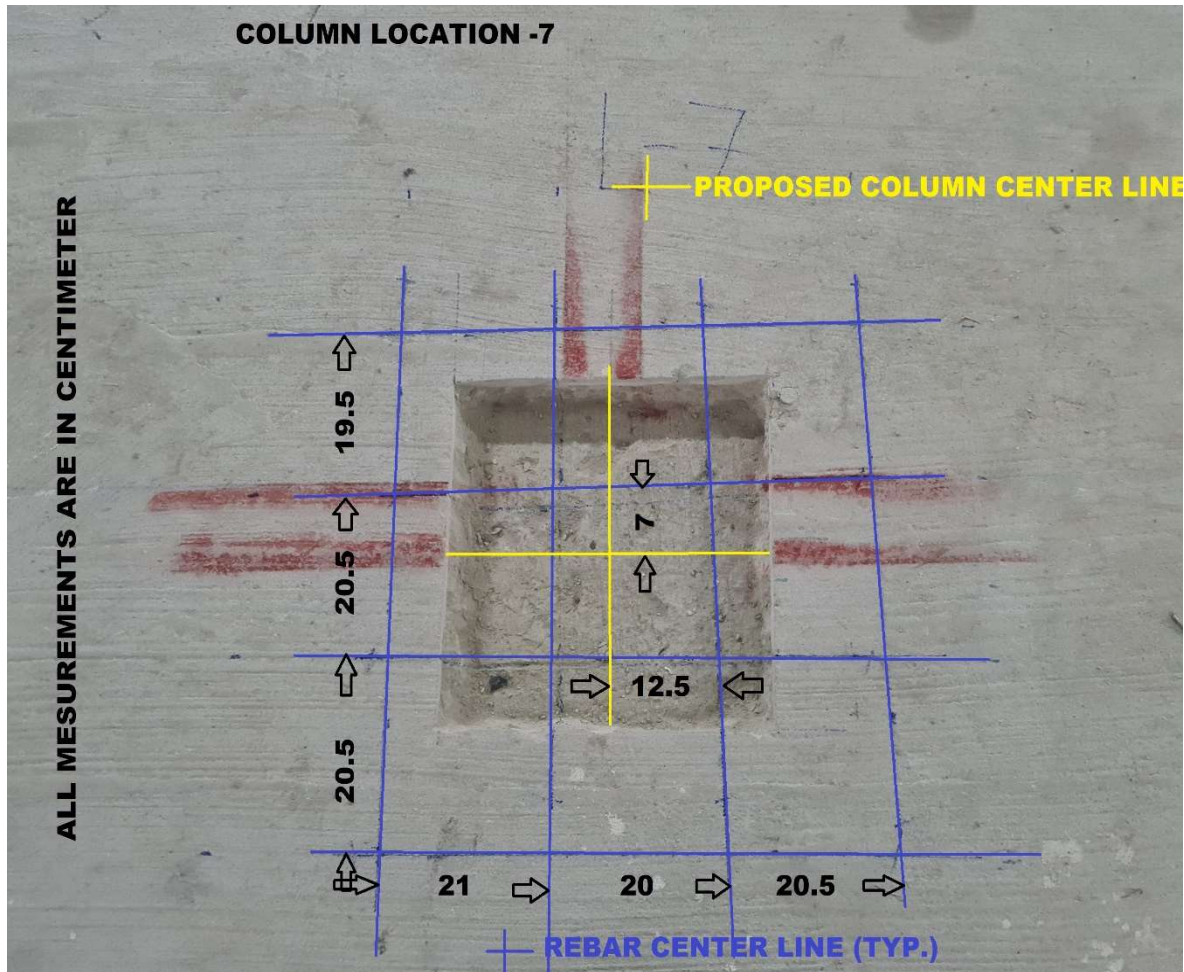
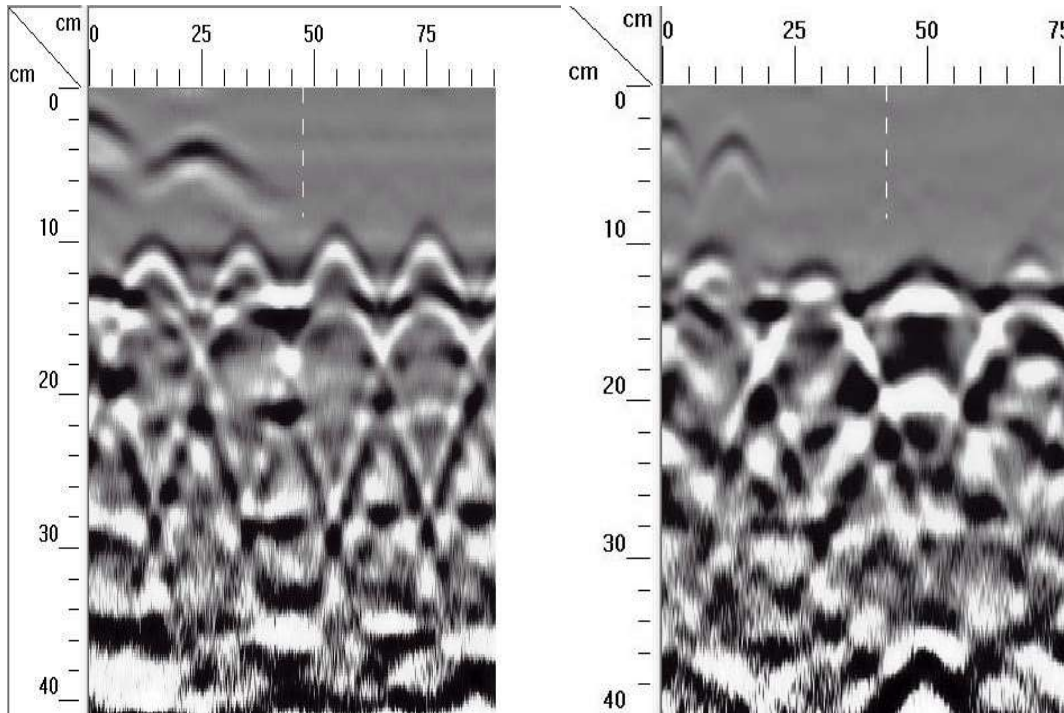
Figure 5.18: Rebar & Proposed column location -7 Layout

**Figure 5.19: GPR Images of Column location -7**

Based on the results of SC-GPR survey, the proposed column location -7 on the 2.6m width x 300 mm thick precast slab. The column location is 2490 mm from the center of the beam(Beam-A) towards left side & 3950 mm from the RC-1 & RC-2 center line downwards ( See Figure 5.1). The rebar center line and proposed column center line is physically marked on the floor ( See Figure 5.18). From the center of the rebar, 25 mm plus half of the dia. of the hole will be safe drilling location in all directions. However this subject to structural Engineers approval for final drilling location.

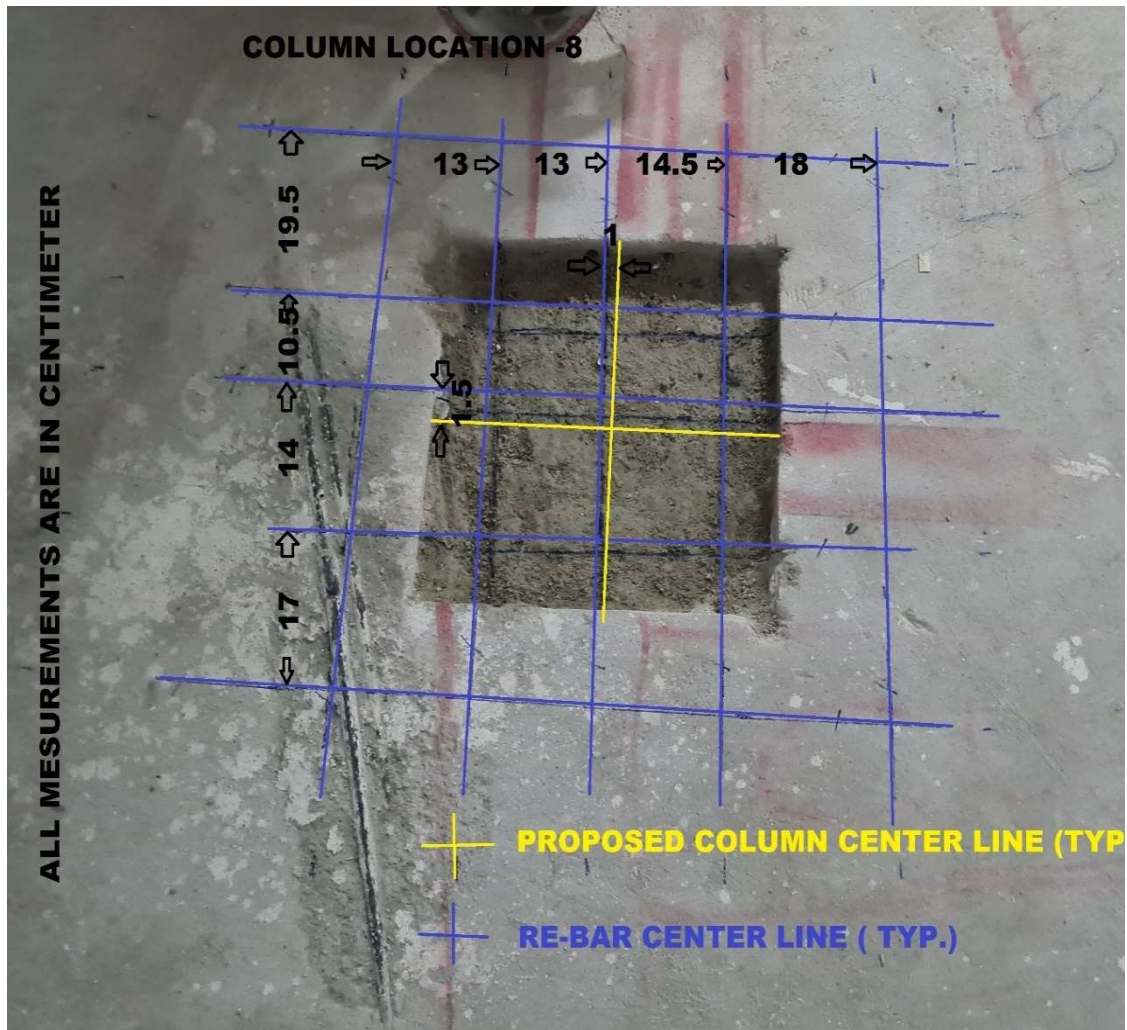
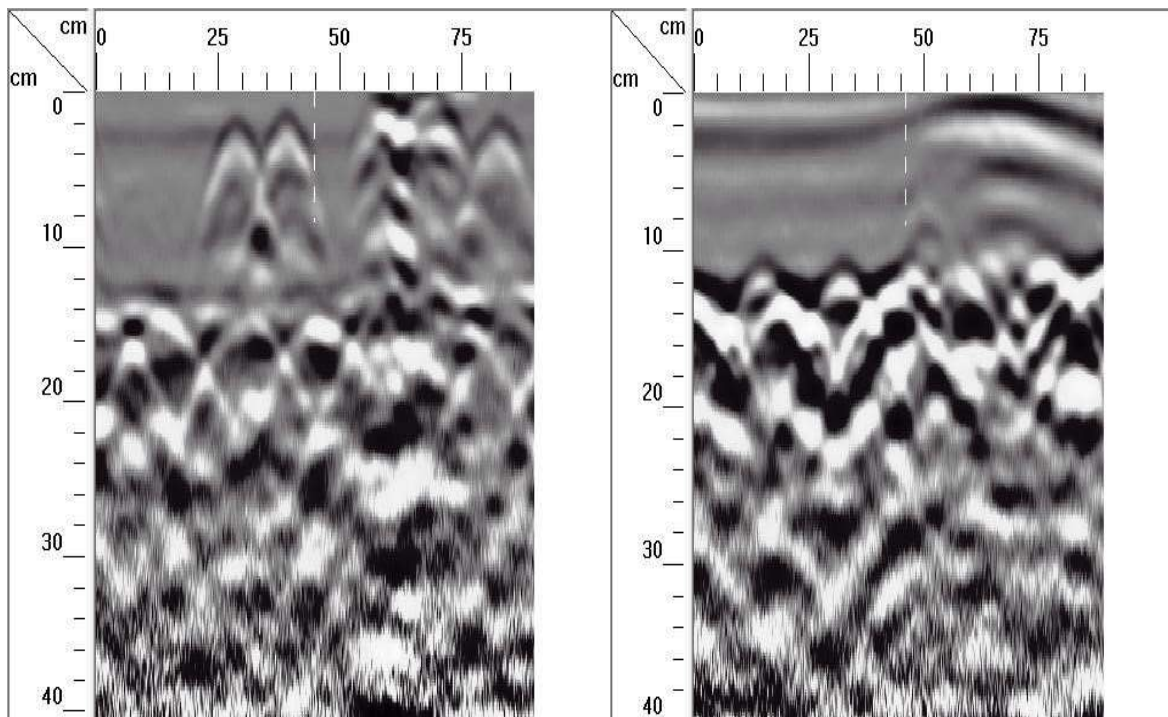
**Figure 5.20: Rebar & Proposed column location -8 Layout**

**Figure 5.21: GPR Images of Column location -8**

Based on the results of SC-GPR survey, the proposed column location -8 on the 2.8m width x 450 mm beam ( Beam-B) is very near to the 600 mm dia. circular column. The column location is 400 mm from the center of the column ( RC-2) towards left side & 335 mm from the column center line ( RC2 & RC-1 ) downwards ( See Figure 5.1). The rebar center line and proposed column center line is physically marked on the floor ( See Figure 5.20). From the center of the rebar, 25 mm plus half of the dia. of the hole will be safe drilling location in all directions. However this subject to structural Engineers approval for final drilling location.

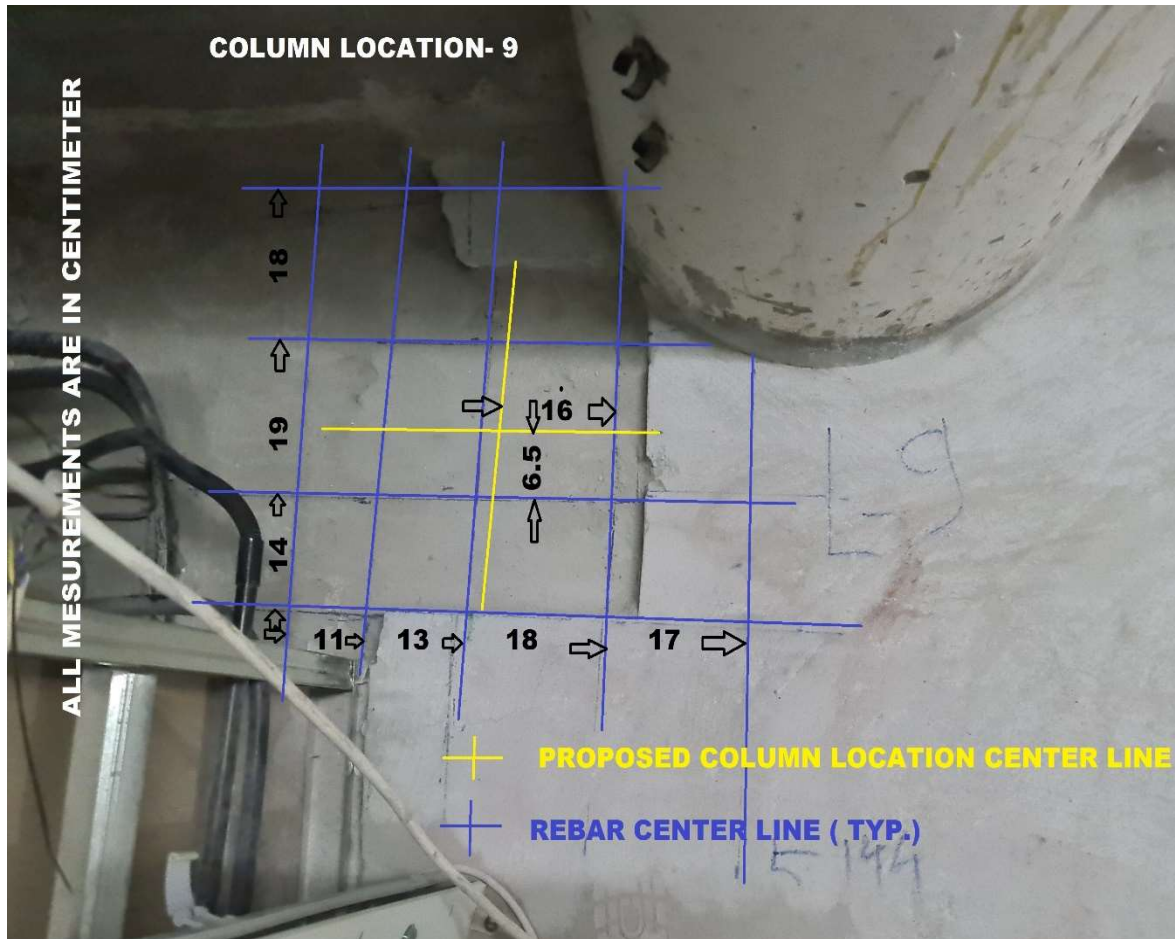
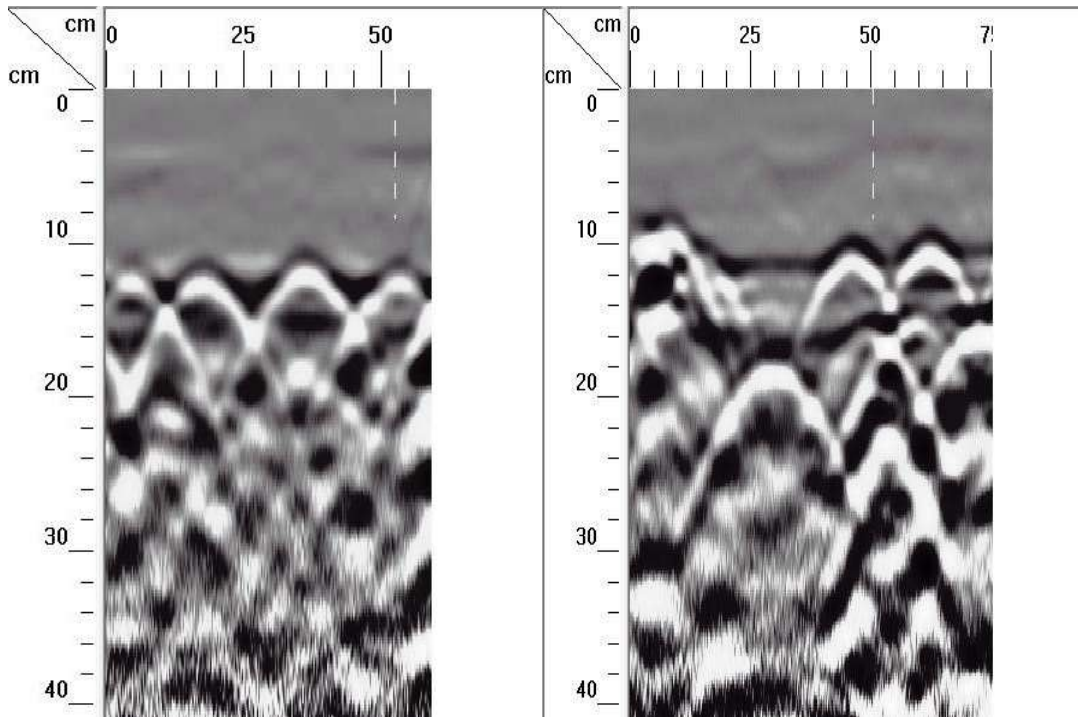
**Figure 5.22: Rebar & Proposed column location -9 Layout**

**Figure 5.23: GPR Images of Column location -9**

Based on the results of SC-GPR survey, the proposed column location -9 on the 2.8m width x 450 mm beam ( Beam- B). The column location is 400 mm from the center of the beam towards left side & 3995 mm from the column center line ( RC-1 & RC-2 ) downwards ( See Figure 5.1). The rebar center line and proposed column center line is physically marked on the floor ( See Figure 5.22). From the center of the rebar, 25 mm plus half of the dia. of the hole will be safe drilling location in all directions. However this subject to structural Engineers approval for final drilling location.
